**MEMPHIS RESERVOIR DAM  
SCOTLAND COUNTY, MISSOURI  
MO 10163**

**PHASE I INSPECTION REPORT  
NATIONAL DAM SAFETY PROGRAM**

Name of Dam: Memphis Reservoir Dam, Missouri Inv. No. 10163  
State Located: Missouri  
County Located: Scotland  
Stream: Unnamed Tributary of the North Fabius River  
Date of Inspection: October 4, 1978

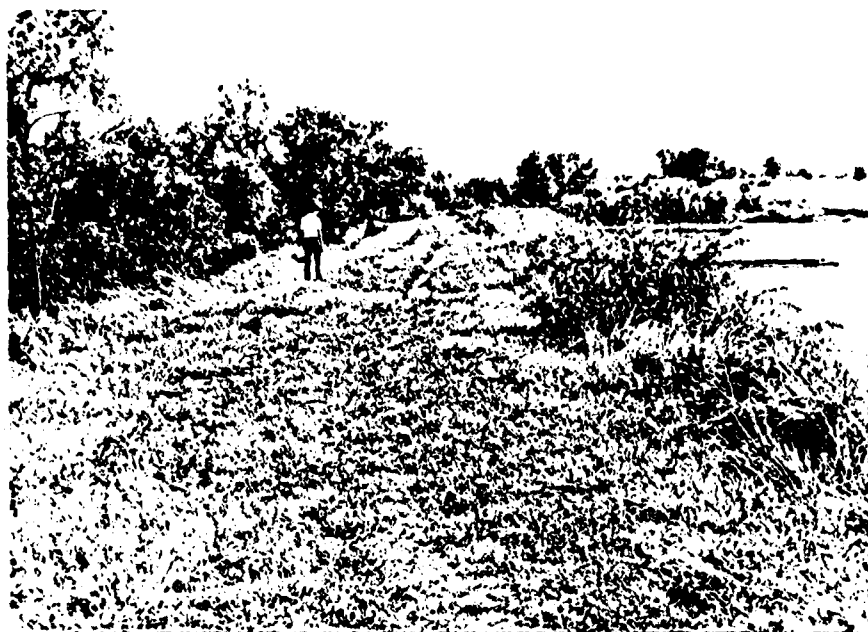
Photo 1 - View along crest of dam taken from near left abutment.

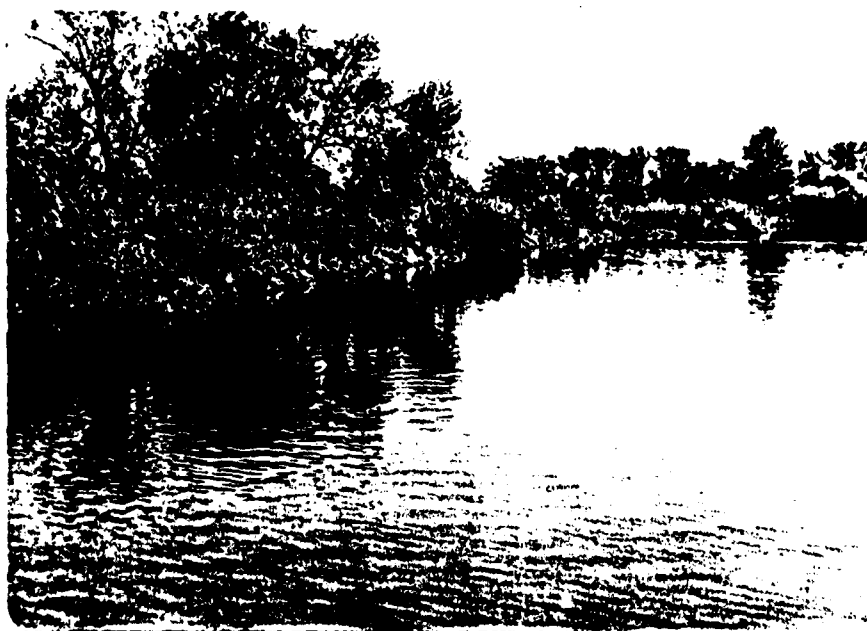
1. The trees and brush beginning to grow on the upstream embankment slope.
2. The vegetation growing in the approach channel for the service spillway and the slotted spillway.
3. The deteriorated concrete and leakage observed in the concrete channel of the service spillway.

Photo 2 - Picture of upstream slope of embankment taken from left side of dam.

The trees starting to grow on the upstream embankment slope should be cut before they become a hazard to the embankment. The downstream embankment slope should be maintained in its present condition.

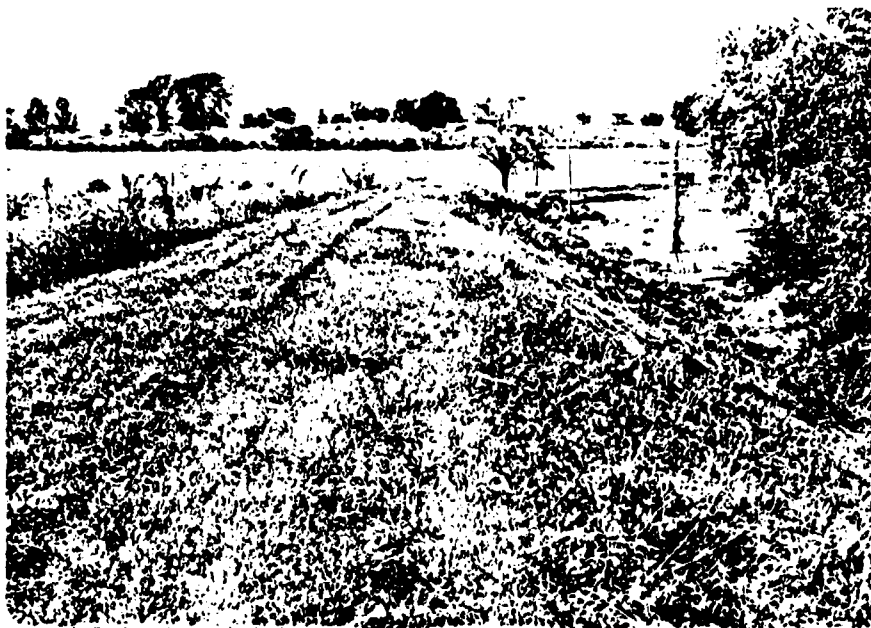
Photo 3 - Picture of crest and downstream embankment slope taken from near center of dam looking toward left abutment.

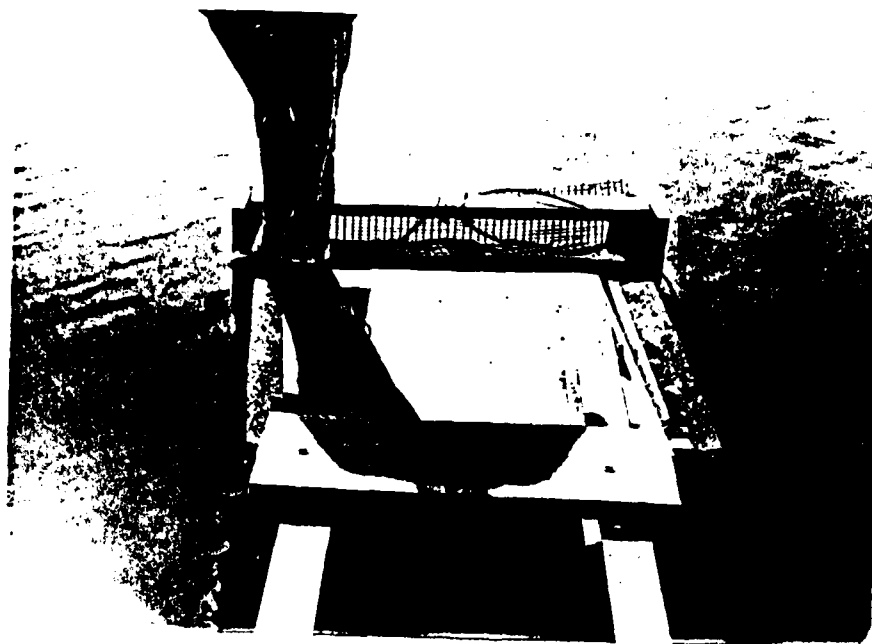
Inspection was made of the unsubmerged portion of the intake tower. The concrete which could be observed was old, but in satisfactory condition. The top of the tower is covered by a steel sheet cover which could not be removed. A heavy wire screen mounted to a crude wooden frame was suspended over the face of one side of the tower; presumably this is a trash screen over the intake opening.

Photo 5 - Picture of intake structure for water supply piping.

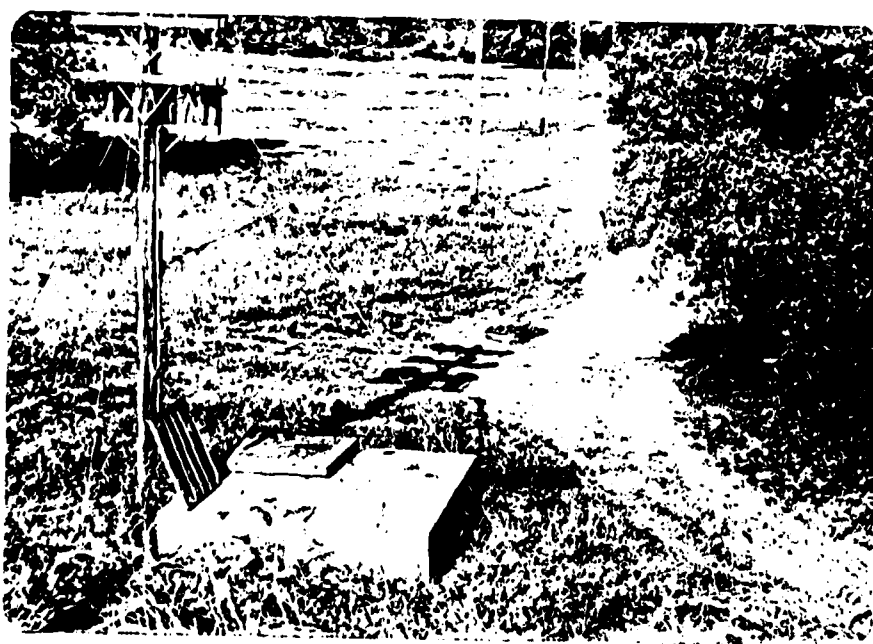
The cover of the pump vault was removed and the vault was entered for inspection. The appearance of the pumping and piping equipment was satisfactory, except there was several inches of standing water over the vault floor, and the electrical control boxes were open and the exposed wiring was in disarray. It was obvious from the condition of the wiring that the pumps were not operational.

connected in parallel to a 6-inch discharge line. The appearance of the pumping and piping equipment in the vault was satisfactory, except there was several inches of standing water over the vault floor and the electrical control boxes were open, with the exposed wiring in disarray. It was obvious from the condition of the wiring that the pumps were not operational, due to a lack of maintenance.

Photo 6 - Picture of pump house vault for water supply.

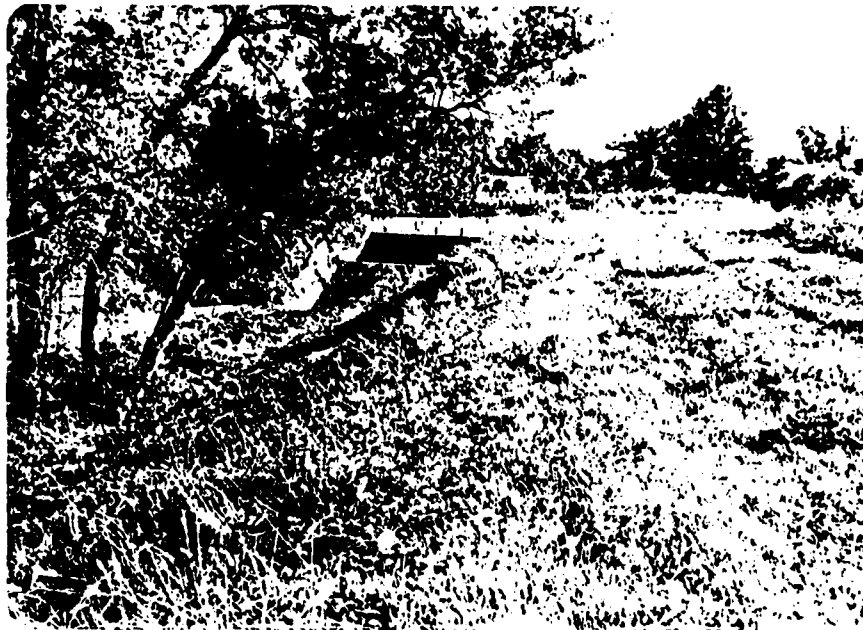
Spillway discharge from all the spillways merge into the natural channel at approximately 70 feet downstream of the embankment toe. The downstream channel is an unlined trapezoidal channel which was sparsely covered with fallen tree trunks and debris at the time of inspection. However, this minor obstruction in the channel does not seem to pose serious restrictions to the spillway capacity. Signs of moderate erosion and sloughing on the right bank of the channel were observed.

Photo 7 - Picture of downstream channel of spillway taken from near center of dam toward right side of dam.

The downstream channel may require remedial work following discharges through the spillway during flood conditions, but no immediate remedial work is required at this time.

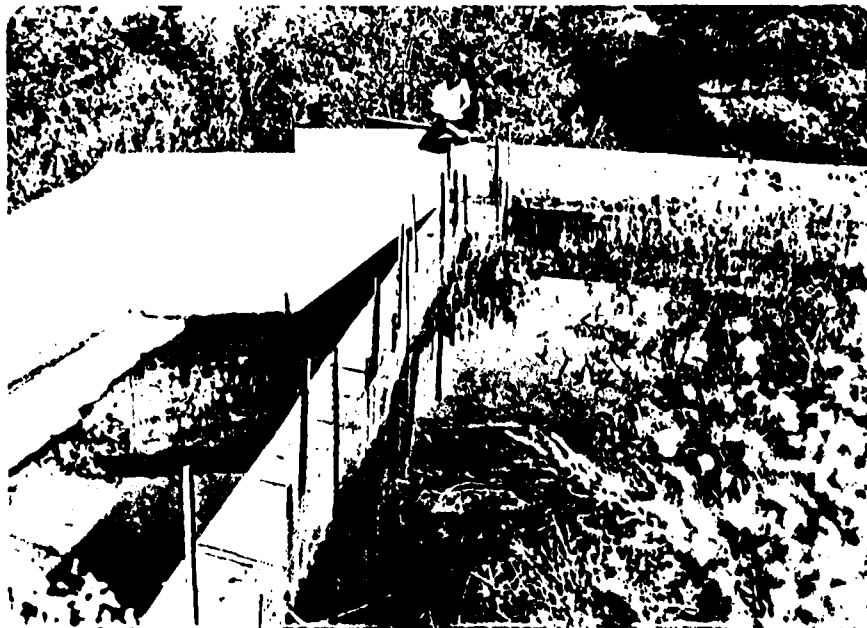
Mostly due to the old age of the structure, the service spillway shows signs of deterioration. Some leakage is occurring through the vertical concrete weir. In addition, vertical and horizontal cracking, and concrete spalling and erosion was observed throughout the concrete channel. Dense grasses are growing in the spillway approach areas.

Photo 8 - Picture of concrete overflow crest of service spillway taken at left side of spillway.

The concrete spillway structures, although old and deteriorating, are in *satisfactory structural condition*. Some grouting to stop the leakage should be performed, and patching of badly spalled areas should be done as it becomes necessary.

The general physical condition of the dam and appurtenant structures is fair. The leakage through the service spillway crest should be stopped, and patchwork to the deteriorating concrete should be done as it becomes necessary.

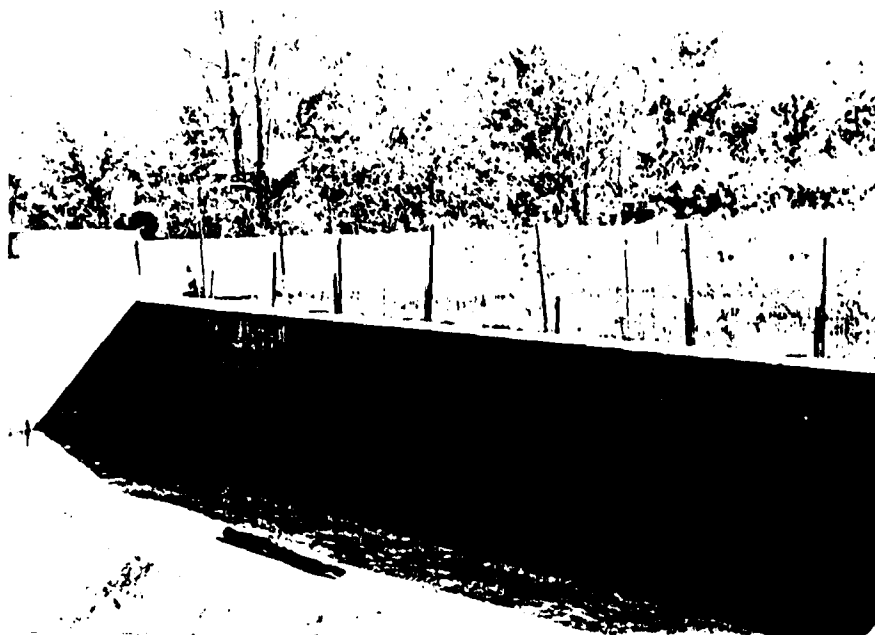
The service spillway structure is deteriorating. Vertical cracks, moderate erosion and spalling on the concrete were apparent. The right bank of the exit channel shows signs of a moderate degree of erosion and sloughing. There is grass growing in front of the spillway entrance of both the service spillway and the No. 2 spillway.

Photo 9 - Picture of concrete overflow of service spillway taken from downstream of spillway.

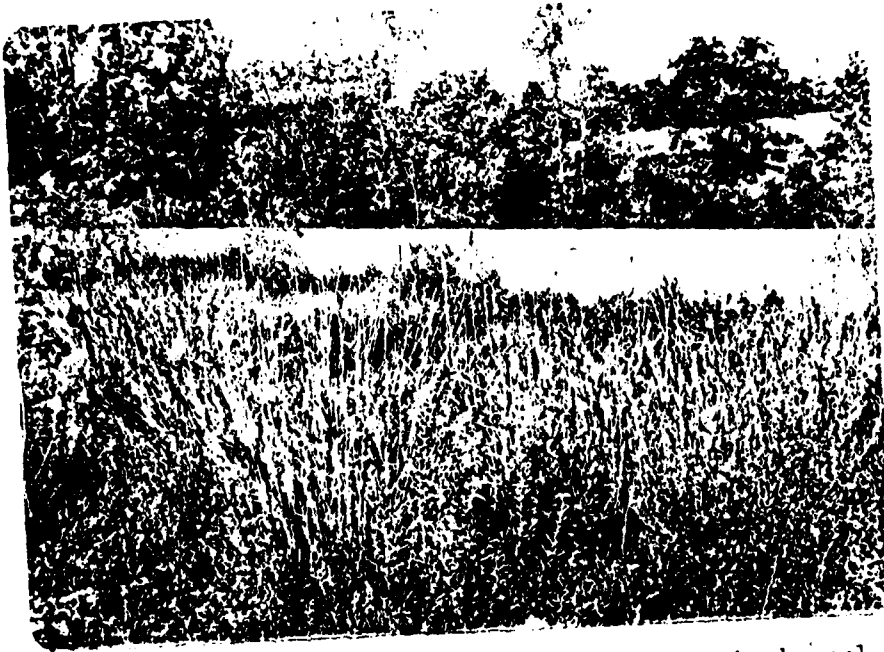
Photo 11 - Picture of emergency spillway approach channel and crest.

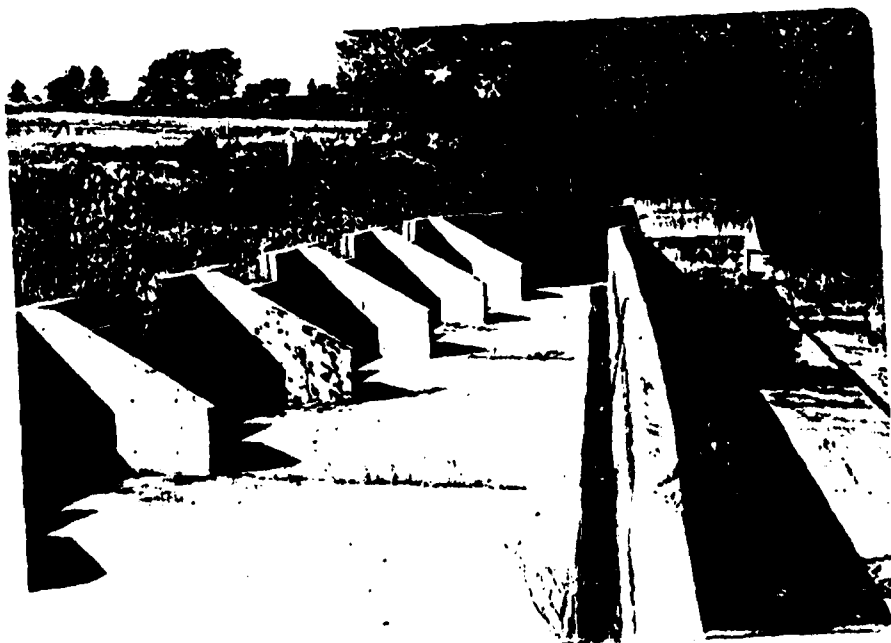
No post construction changes exist which will affect the structural stability of the dam. At spillway No. 2, the new spillway wall replaced an old wall which had failed.

Photo 12 - Picture of crest of emergency spillway and failed downstream wall taken from right abutment of spillway.
